LAKEWOOD DAM
JACKSON COUNTY, MISSOURI
MO. 20242

PHASE 1 INSPECTION REPORT NATIONAL DAM SAFETY PROGRAM

AUGUST 1978

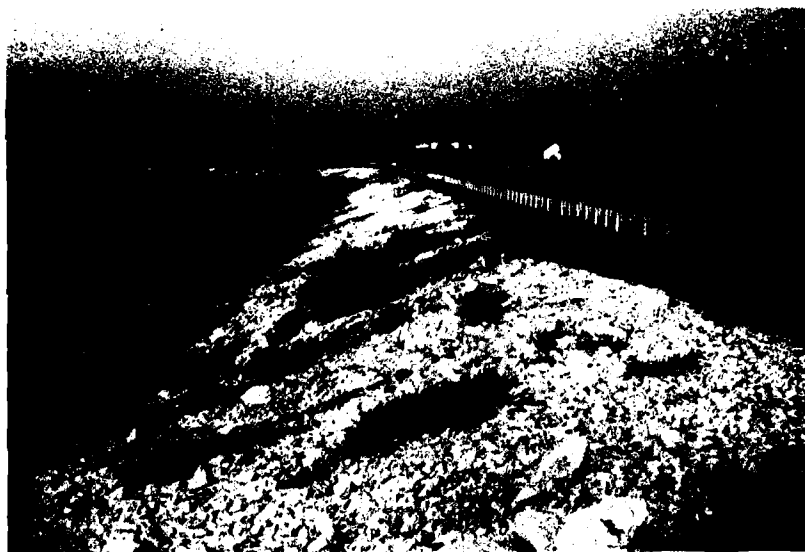
PHOTO 1: UPSTREAM FACE OF DAM (LOOKING WEST)

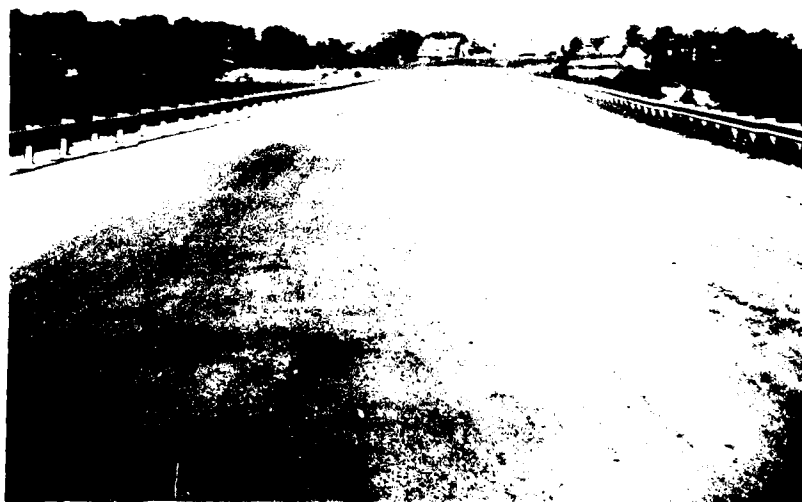
PHOTO 2: TOP OF DAM

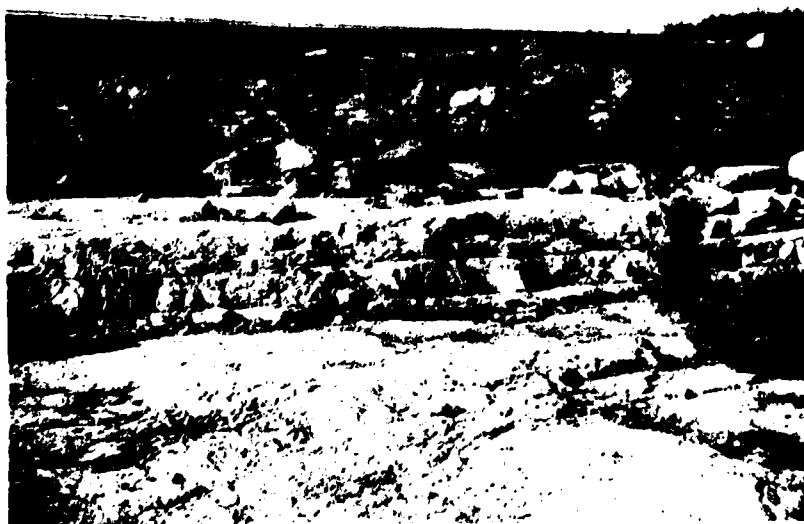
(1) Concrete spillway and the spillway discharge channel are in good condition. Seepage was observed between the limestone and shale layers of the discharge channel.

PHOTO 4: LOOKING UPSTREAM AT SPILLWAY DISCHARGE CHANNEL
